# BEDP ENVIRONMENT DESIGN GUIDE

## AUSTRALIAN ETHICAL INVESTMENT HEADQUARTERS, 6 STAR GREEN STAR OFFICE REFURBISHMENT, CANBERRA

*The refurbishment of Trevor Pearcey House for the new Australian Ethical Investment Headquarters was designed by Collard Clarke Jackson Architects and in 2007 was the first building in the ACT and only the third in Australia at the time to receive a 6 Star Green Star rating. More importantly it was the first wholly privately funded project to receive a six star rating. This case study provides a detailed description and evaluation of the whole process of taking an ordinary 19 year old office building and changing it to a leading example of low cost environmental design.*

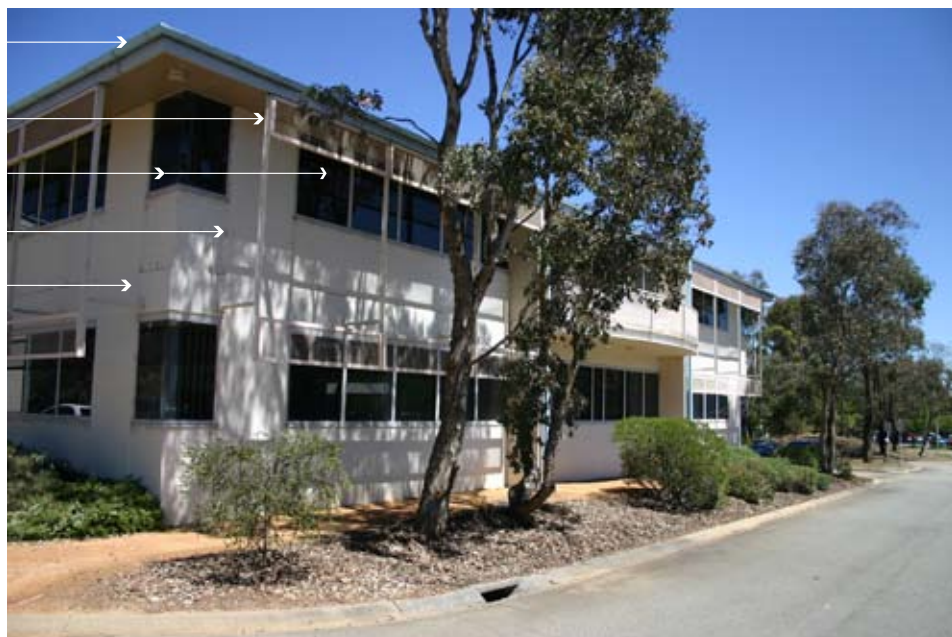
Uninsulated roof

Poor sun shading

Single glazed windows

Uninsulated infill

Thermal bridging concrete columns and beams exposed inside and out

**Figure 1. Existing building exterior**  
(Source: Kevin Miller)

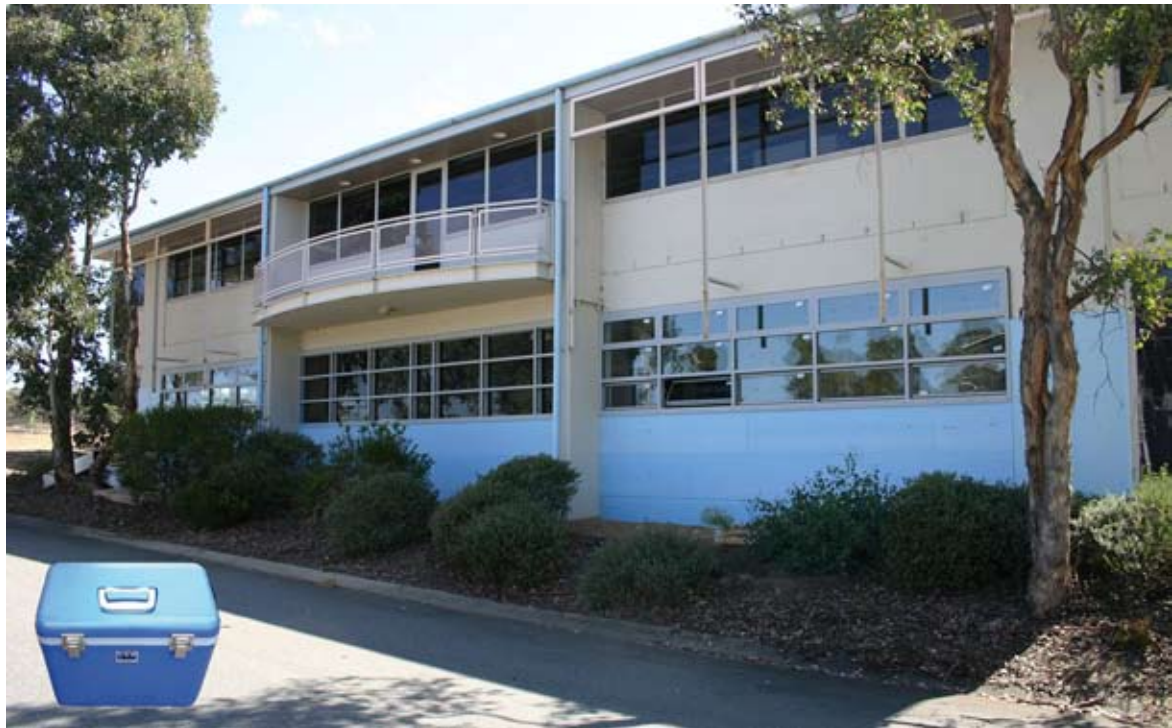
**Figure 2. Thermal insulation was added**

The building was made more 'esky' like by significantly improving the external fabric. This involved insulating the outside of the building with 75mm thick rigid closed cell, extruded polystyrene which improved the R value of the walls to 3.7. On the first floor the

suspended ceiling was temporarily removed and R6 insulation was added to the underside of the roof. The existing windows were then exchanged with operable double-opening, double-glazed windows.

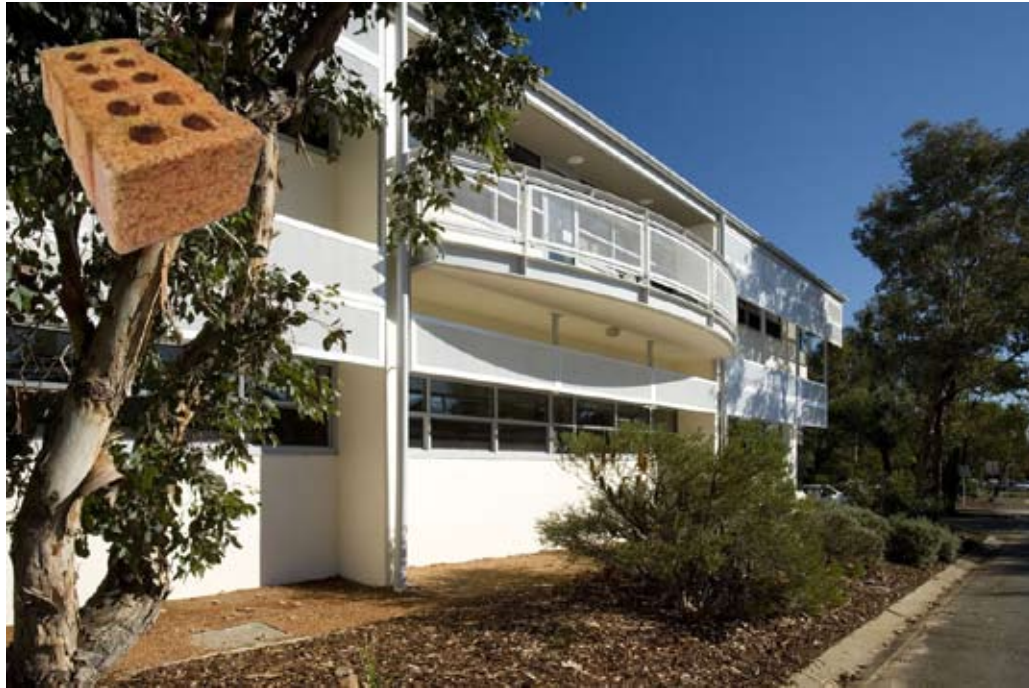
**Figure 3. Thermal mass was captured**  
(Source: Kevin Miller)

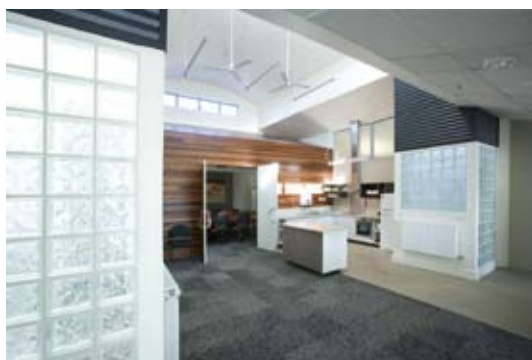
**Figure 8. First floor lunch room**

This area originally had a flat ceiling at 2400mm high. Note the combined light and ventilation stack to the right with glass blocks and the clerestory windows. The sink, carpet, joinery, timber panelling, doors and door hardware, glass blocks, ceiling tiles and the splashback (former computer room floor tile) are all reused.

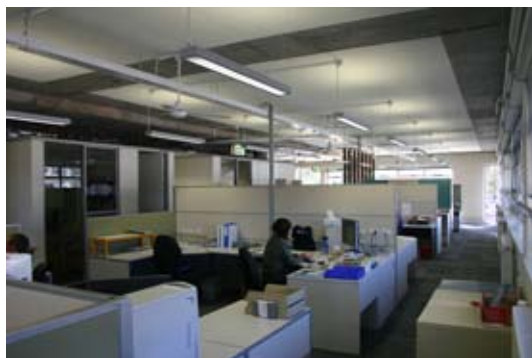
**Figure 9. Ground floor office**

The former suspended ceiling has been removed to expose thermal mass of slab over. Ceiling fans have been added for air movement, suspended T5 lighting with an up-light component and slab over painted white for greater reflectance.

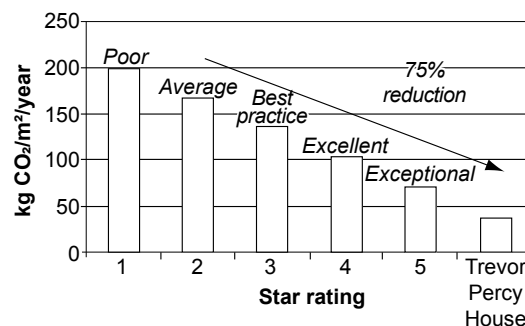
The building owner has also modelled to achieve a 47 per cent better than 5 star Australian Building Greenhouse Rating. This is 75 per cent better than the original 'average' building. Australian Ethical has also committed to purchasing 100% renewable electricity.

**Figure 10. Carbon emissions**

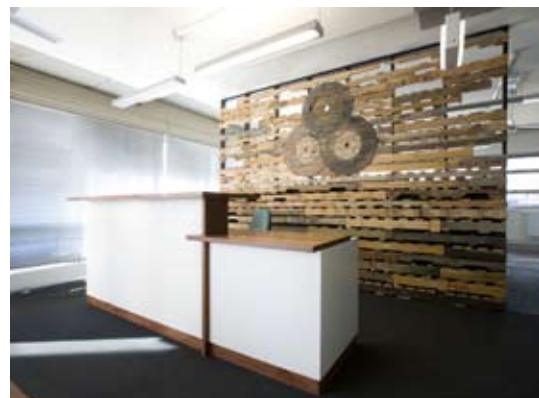
**Figure 12. Reception feature wall emphasising materials reuse**

The feature wall made from odd sized pallets destined for landfill with the client's tri-circle logo made from old timber cable reels.

Two resulting features provide a good example of both the amount of recycling and of the refurbishment's personality. One is a display of art work around the building depicting environmental degradation made from recycled computer floor tiles and the other is a wall in AEI's reception constructed from odd-sized timber palette ends and timber cable reels destined for landfill.

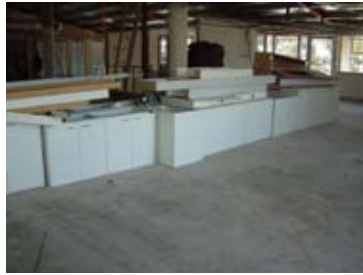
**Joinery cupboards – 90 per cent reused.**

These had to be stacked and moved around as the construction work progressed.

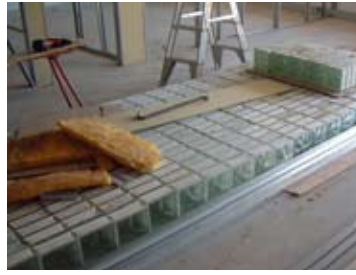
**Glass blocks – reused.**

The specification had allowed for 30 per cent wastage, however all were saved and an additional wall was able to be built.

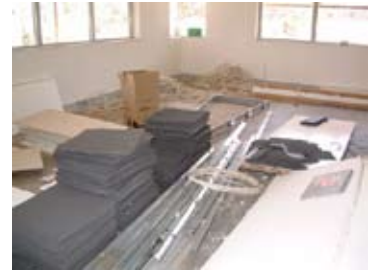
**All existing carpet tiles – reused.**

Also steel partition studs, ceiling tiles, doors and door frames.

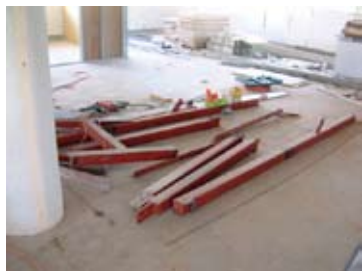
**Steel – reused.**

Steel from the hanging platforms from the dismantled air-conditioning units was reused for a bike enclosure.

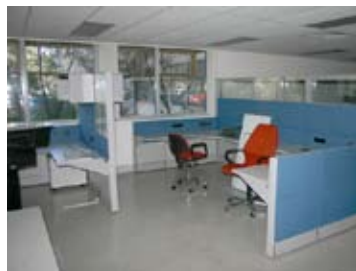
**Old workstations – reused.**

These were left in the building by a previous tenant, and were reused in the IT area.
