BEDP ENVIRONMENT DESIGN GUIDE

CONVERSION OF A HERITAGE LISTED INDUSTRIAL BUILDING – UTAS SCHOOL OF ARCHITECTURE AND DESIGN

Roger Fay and Ceridwen Owen

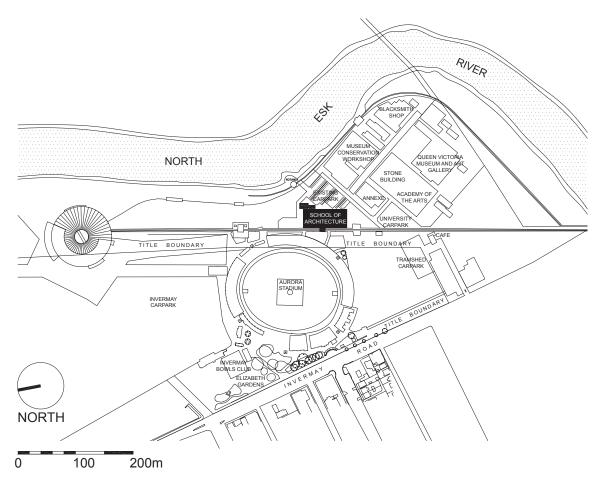
Figure 2. Location/site plan (Source: Six Degrees Architects, 2005)

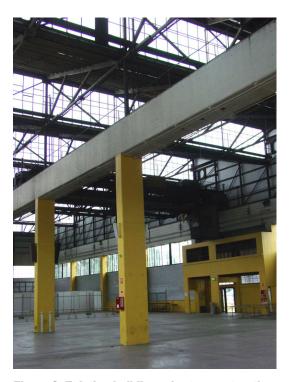
Figure 3. Existing building prior to construction (Source: Roger Fay, 2006)

In addition to the project brief and ESD targets discussed above, the key issue underpinning the design of the school was maintaining the existing character of the building. With respect to the heritage listing of the building, the primary concerns were preserving the clarity of the existing spatial volume, concrete structure

and sawtooth roof, and the presence of the gantry cranes. A further driving factor was the connection between the original function of the building as a workshop for trains and its new life as a 'workshop' for architecture students.

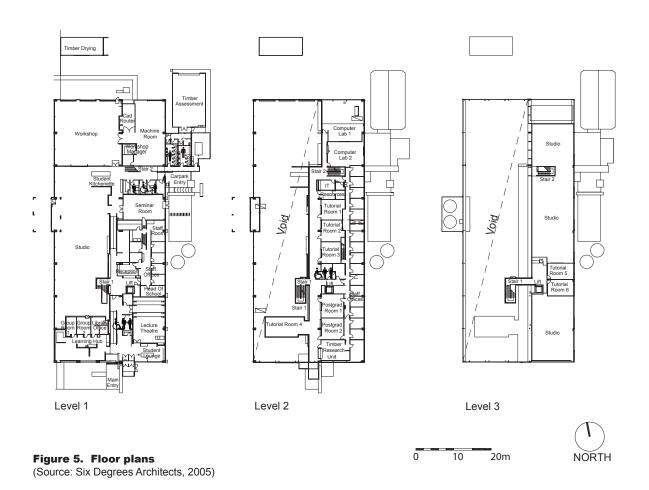
Figure 6. Longitudinal section (Source: Six Degrees Architects, 2005)

The main functions are 'compressed' within a new three-storey structure occupying the eastern edge of the building, retaining much of the volume of the original workshop. Dedicated teaching spaces, administration and academic offices are located on the ground and first floor while the top storey is configured as an openplan flexible studio space. The main public facilities, incorporating a lecture theatre and learning hub accessible to all the university's students, are located at the south end of the building with the workshop and vehicle loading to the northern end.

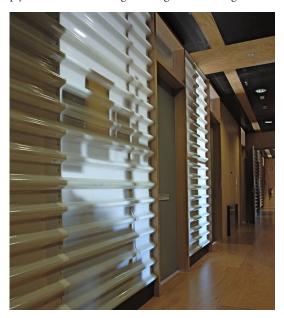
Figure 12. Internal corridor with translucent wall panels

Daylight penetration is maximised (Source: Roger Fay, 2008)
